RAILWAY INVESTIGATION REPORT R13T0192

CROSSING COLLISION

**VIA RAIL CANADA INC. PASSENGER TRAIN NO. 51
OC TRANSP0 DOUBLE-DECKER BUS NO. 8017
MILE 3.30, SMITHS FALLS SUBDIVISION
OTTAWA, ONTARIO
18 SEPTEMBER 2013**

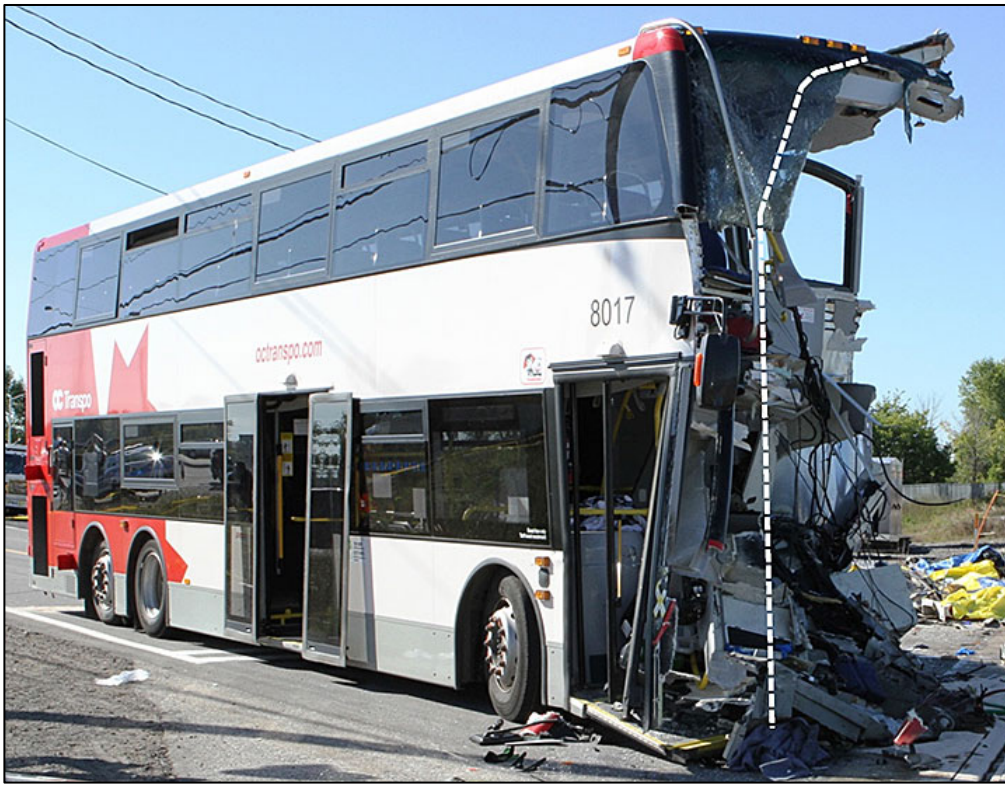
The right side wall of the bus had little damage, except for the panel located above the front door, which was bent to the left, in the direction of train movement. The right front corner pillar, which serves as the foremost vertical beam for the front door frame, was deformed and disconnected from the chassis at its lower end. Most of the front dome glazing (window) was missing, except for a small portion hanging from the right top corner. The remaining glazing was about 30 inches (76 cm) wide at the bottom. The contour of the remaining glazing was consistent with that of VIA 915's bodywork (Photo 1), as this was the last portion of the bus that contacted the train.

Photo 1. Right side view of the bus (the dotted line represents contour of locomotive VIA 915)

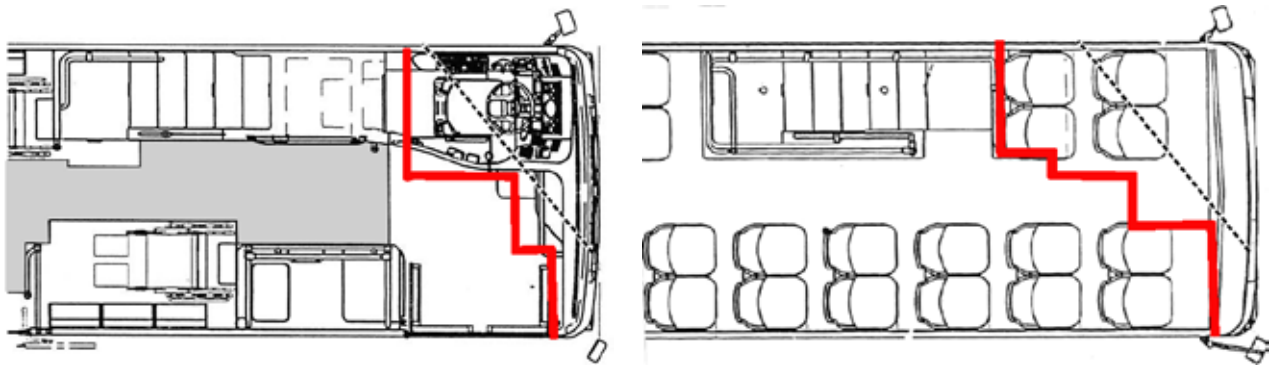
The driver's seat and the 4 seats on the 2 foremost rows of passenger seats on the left side of the upper deck were torn from the bus along with their supporting floor structure (Figure 4), coming to rest on the adjacent roadway west of the bus. The frame of these passenger seats had no significant damage, as the seats had not been directly struck by the train, nor did the impact with the ground exceed the seat design strength.

Figure 4. Schematics illustrating floor separation (lower deck on left; upper deck on right). The solid lines outline the boundary of floor separation. The dotted lines show the estimated line of train movement.

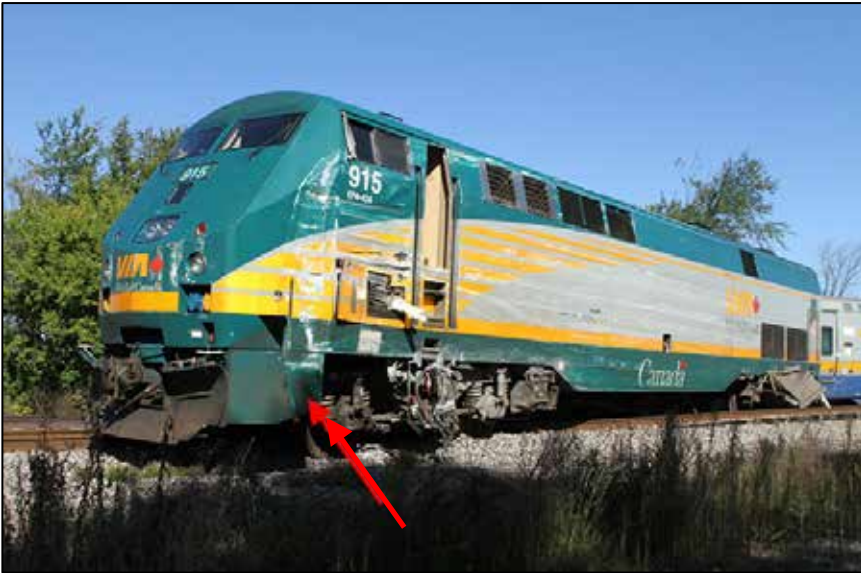
Photo 5. Damage on locomotive VIA 915

Horizontal lines of denting and scoring extended on the left side of VIA 915's bodywork and onto the first 20 feet (6.1 m) of the first passenger car (VIA 3455), as the bus had kept moving forward after the initial impact until it stopped. There was shallow denting along the body side sheets of VIA 915, but the frame of VIA 915 was not deformed.

The bottom portion of the skirt behind the pilot of VIA 915 was 20 inches (51 cm) above the ground level at the point of collision. The side panel was 44 inches (112 cm) above the ground. The chassis of the ADL E500 bus, which was about 17 inches (43 cm) above ground level, had passed beneath the bottom portion of the skirt behind the pilot and side panel of VIA 915.

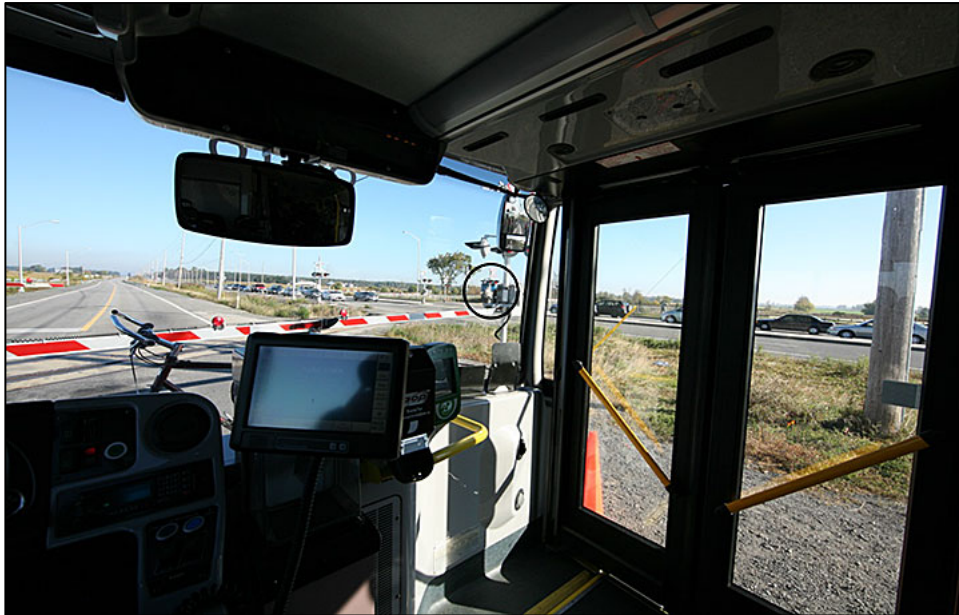
8. From the driver’s location stopped at the crossing, the bus window pillars and door structure obscured the driver’s view of the train (Photo 14).

Photo 14. Wide angle view of approaching train from a bus stopped at the crossing

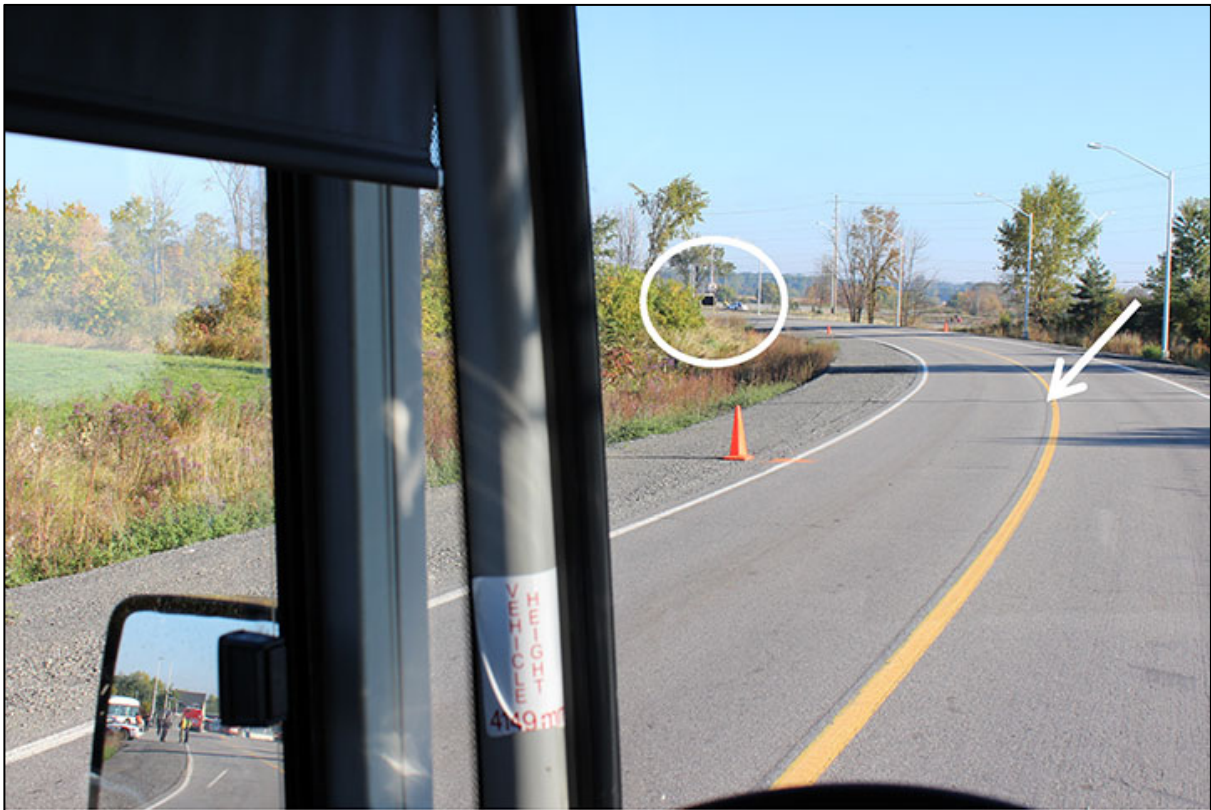
Photo 16. View of Transitway on approach to the crossing (TSB re-enactment 28 September 2013). The arrow identifies the tangent point of the curve. The circle identifies the occlusion point toward which drivers would make anticipatory glances. Note the large sign within occlusion point.
