RAILWAY INVESTIGATION REPORT R13T0192

CROSSING COLLISION

**VIA RAIL CANADA INC. PASSENGER TRAIN NO. 51
OC TRANSP0 DOUBLE-DECKER BUS NO. 8017
MILE 3.30, SMITHS FALLS SUBDIVISION
OTTAWA, ONTARIO
18 SEPTEMBER 2013**

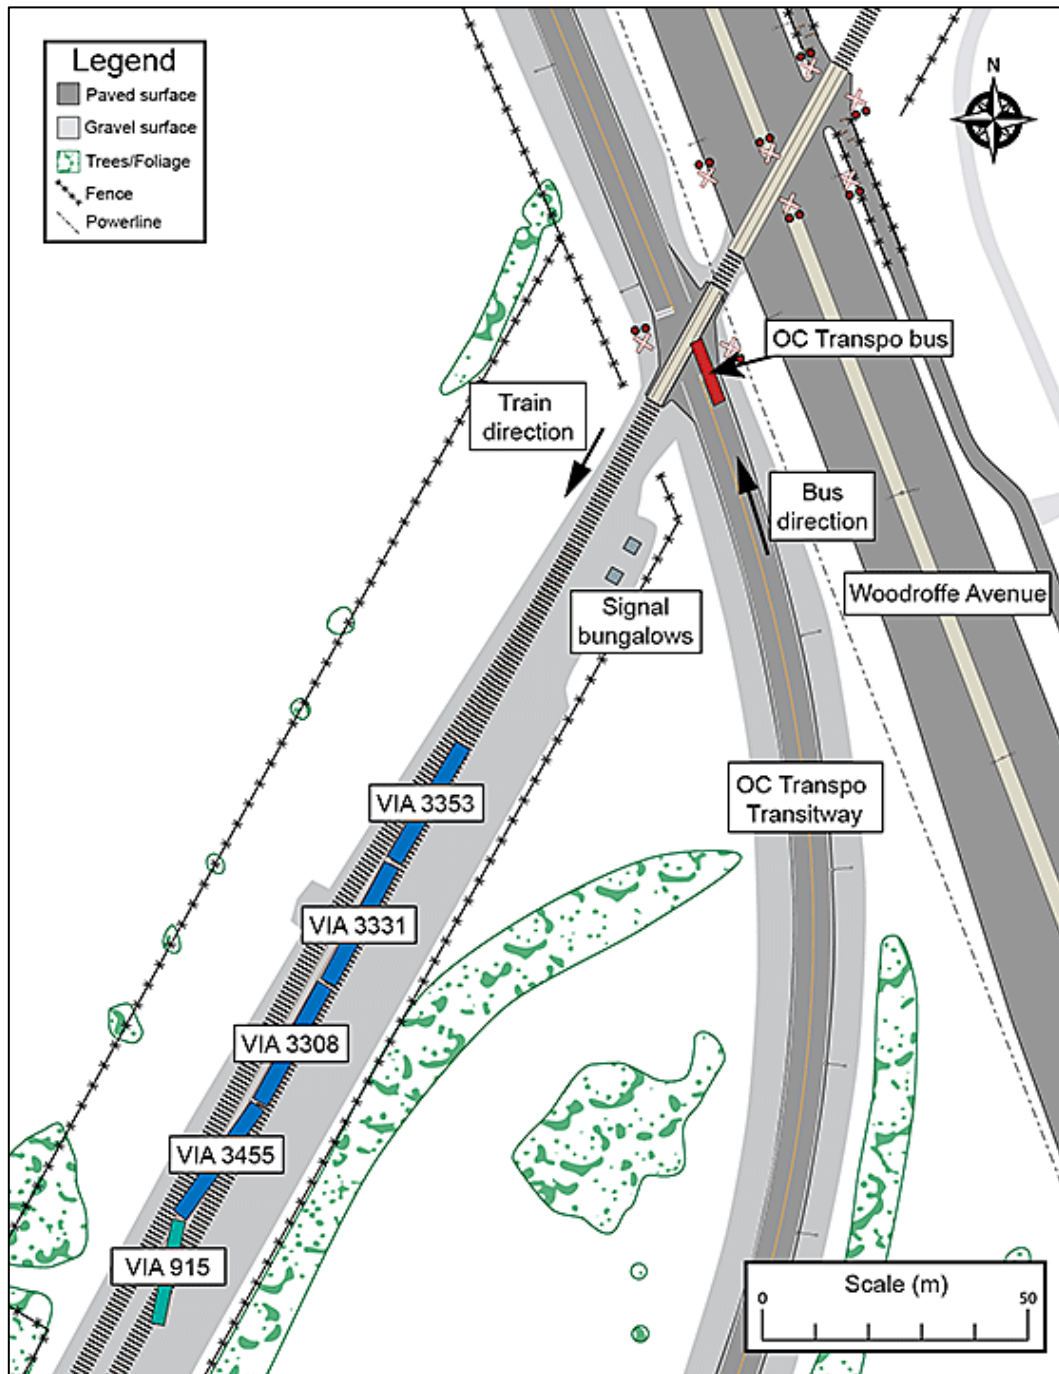
Figure 2. Site diagram

The train subsequently derailed and the locomotive came to a stop approximately 690 feet (210 m) west of the Transitway crossing, just east of the VIA Fallowfield Station (Figure 2).

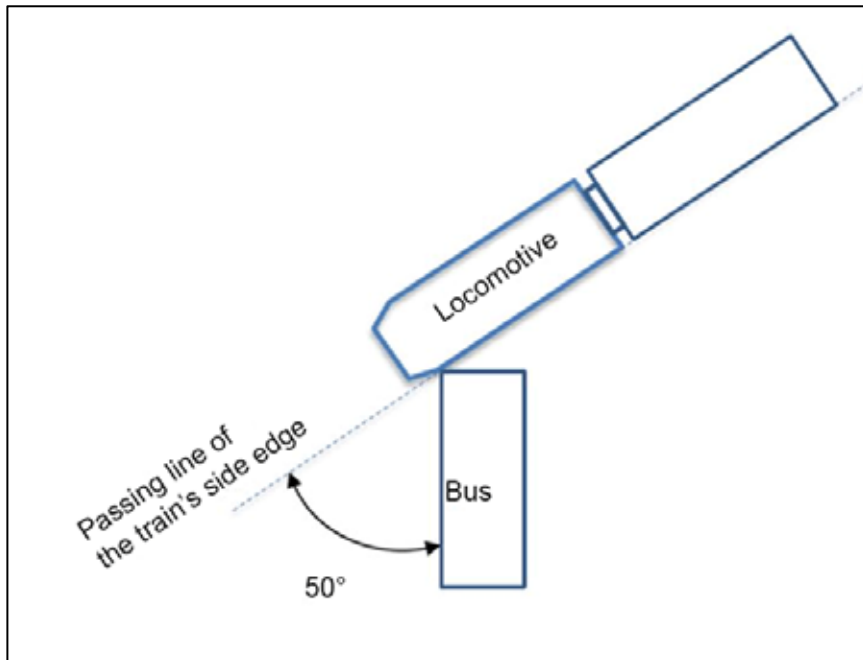
Figure 3. Orientation of the bus and train just prior to impact

At the railway crossing, the Transitway crosses the track at a 50-degree angle. The relative orientation of the bus and the locomotive just prior to impact is depicted in Figure 3.

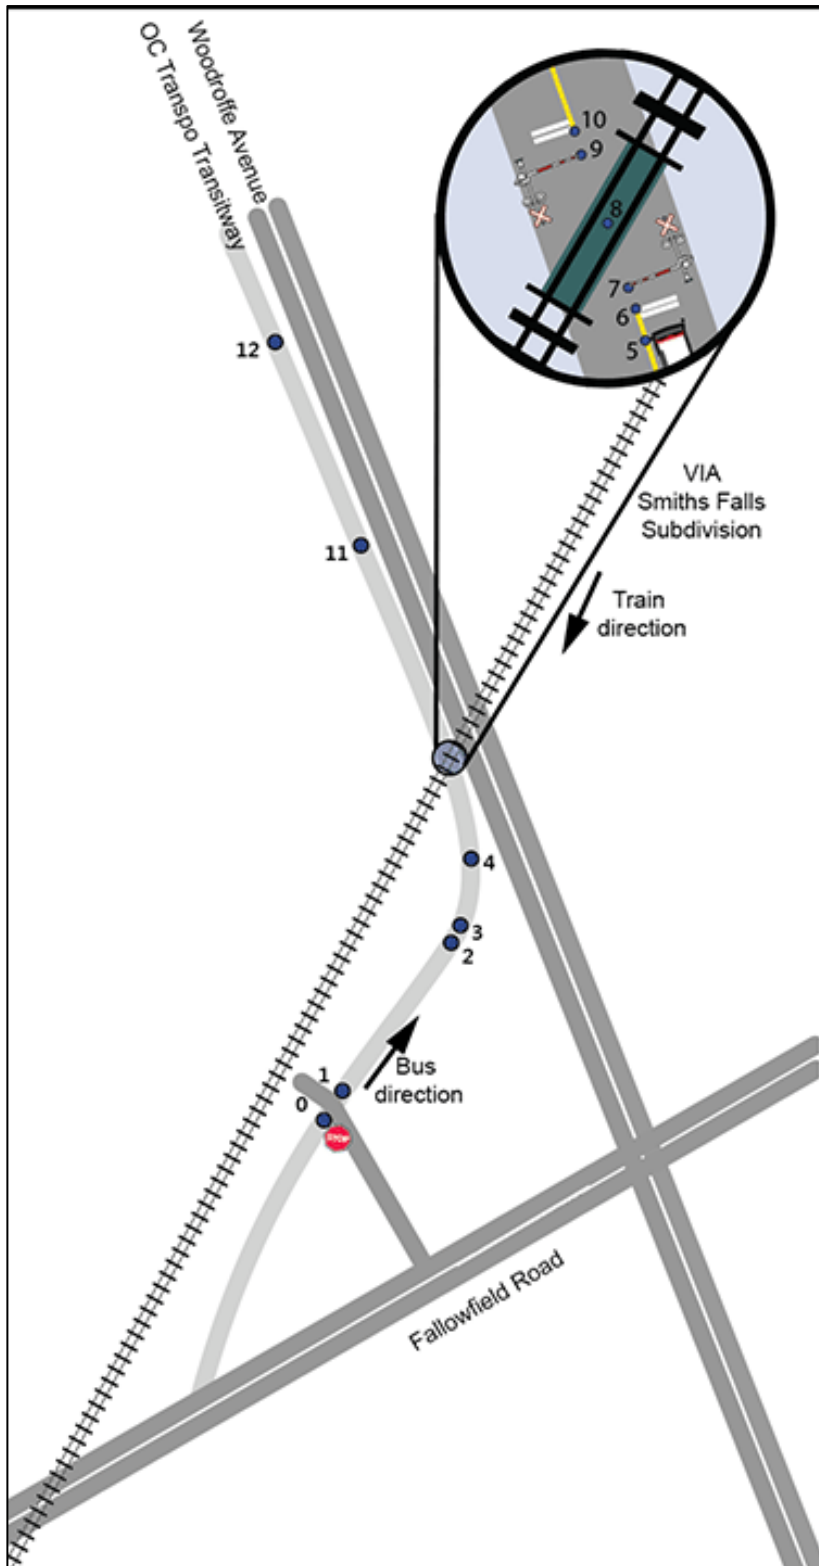
Figure 7. Locations of re-enactment measurements

Timed runs and measurements were made with the bus travelling from the stop sign at OC Transpo Fallowfield Station up to and beyond the crossing on the Transitway (Figure 7 and Appendix C).

1. With the crossing gates inactive, it took between 35 and 40 seconds for the bus to travel from the stop sign to the crossing at the posted road speed of 60 km/h.

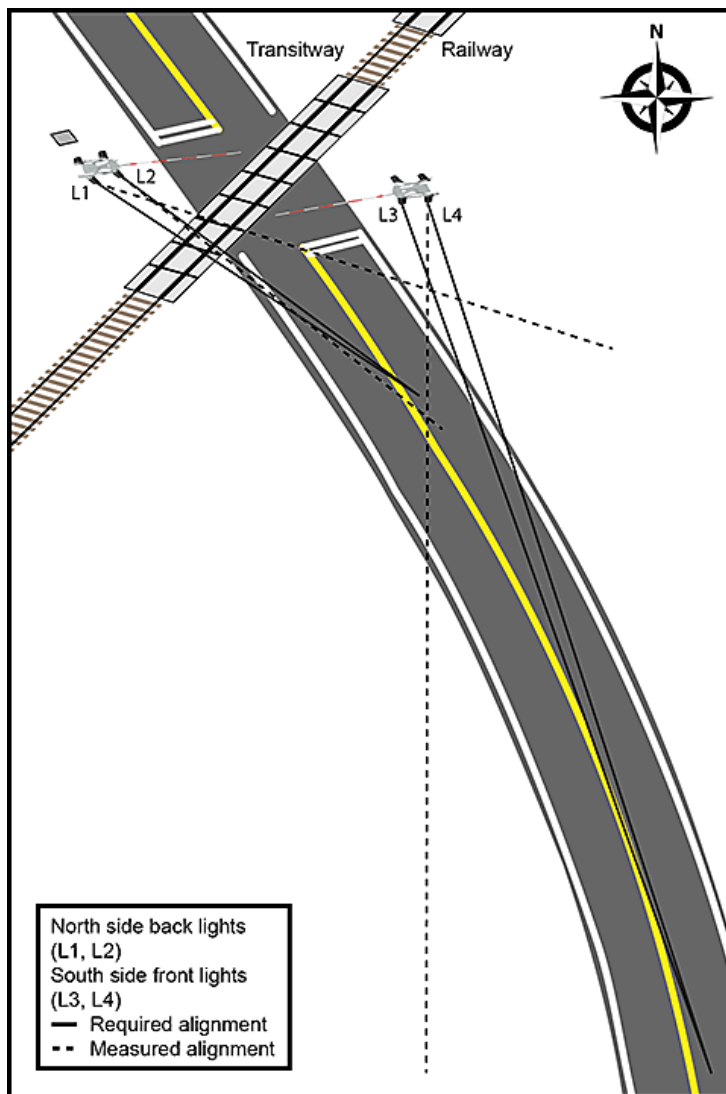
Figure 8. Transitway crossing light layout and alignment

11. Although the crossing LED lights were clearly visible to roadway vehicles on the Transitway, the LED lights facing southward for the Transitway were misaligned. For a road speed of 60 km/h (i.e., Transitway speed limit at the time of the accident), the short lights (back lights located on the north stanchion – L1 and L2 in Figure 8) should have been aimed at a location 50 feet (15.2 m) south of the northbound lane stop line at the crossing, at the driver position, 5.2 feet (1.6 m) above the road surface. The long lights (front lights located on the south stanchion – L3 and L4 in Figure 8) should have been aimed at a location about 280 feet (85.3 m) south of the northbound lane stop line.

- For the south-side front lights (long), the west light (L3) was aligned properly at 280 feet (85.3 m) while the east light (L4) was aimed about 50 feet (15.2 m) to the west, 280 feet (85.3 m) from the south stop line (Figure 8).

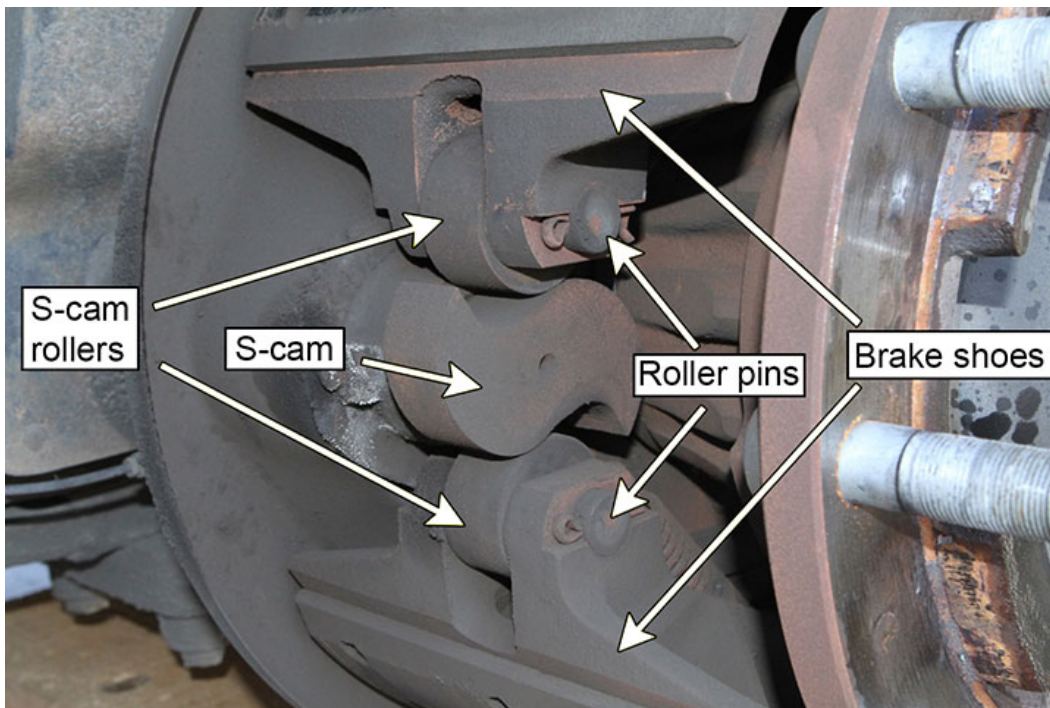
Figure 13. View of S-cam assembly with brake drum removed

The front axle is fitted with disc brake assemblies with electric pad wear sensors and ABS traction control. The front brakes are applied by single diaphragm actuators. The drive and auxiliary axles are fitted with S-cam drum brake assemblies (Figure 13).

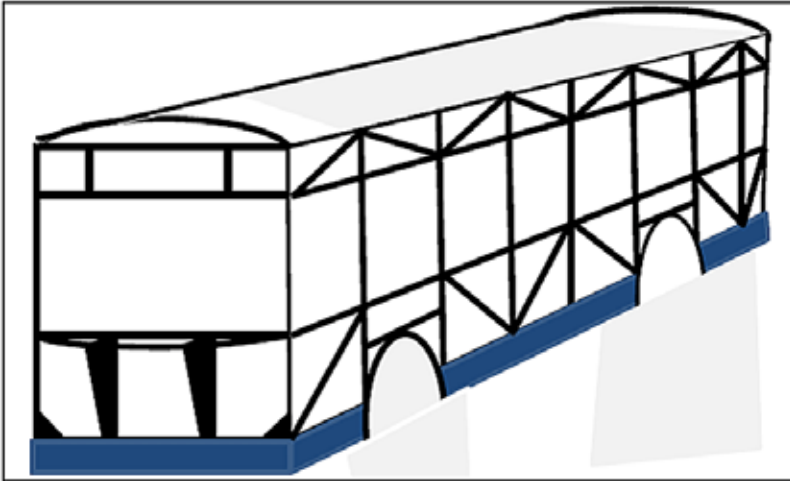
Figure 14. Generic single-deck bus structure schematic

OC Transpo operates a fleet of conventional single-deck buses on the same routes as ADL E500 double-decker buses. The structural design characteristics of other representative single-deck buses were visually examined for comparison. The front-end framing of the single-deck buses examined was made of welded steel beams with joints reinforced with gussets.¹¹³ In some cases, the side walls had a truss design,¹¹⁴ also made of welded steel beams. Figure 14 gives a generic schematic illustration of this type of body structure.

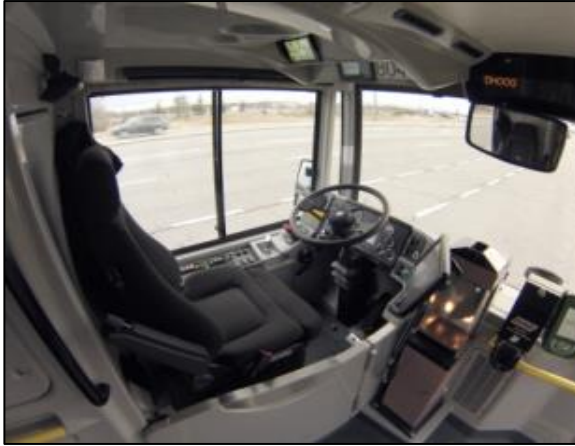
Photo 17. Driver's workstation on ADL E500 bus

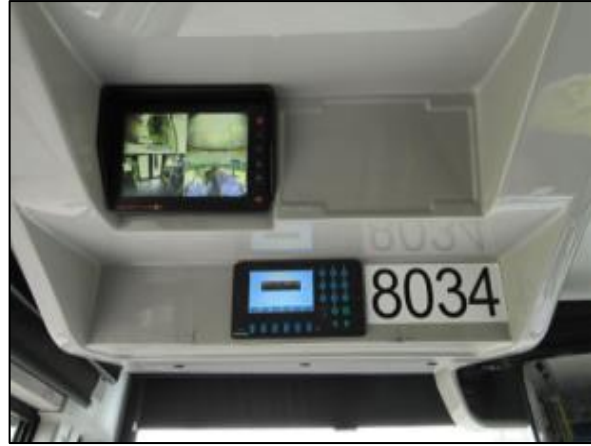
Photo 18. Driver's view of video monitor (upper left)

The 4 quadrant views had been fixed in a standard configuration on all OC Transpo ADL E500 buses as follows:

- the lower left image displayed the side doors;
- the upper left image displayed the stairwell;
- the lower right image displayed the upper deck; and
- the upper right image displayed the exterior rear of the bus.

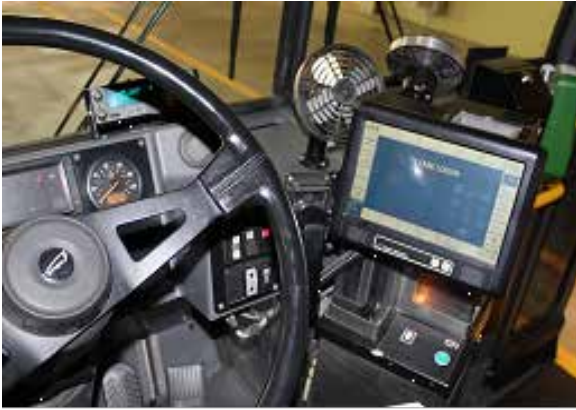
The TCH system used GPS data to display route maps, bus location and an on-time performance schedule adherence bar to drivers. The TCH screen measured approximately 11 inches wide by 8 inches high (28 cm by 20 cm). The display within the screen measured 8¾ inches wide by 5⅜ inches high (22 cm by 14 cm). In all of the bus models, the TCH screen was positioned to the right of the steering wheel at dashboard height (Photo 19). The position of the TCH screen was slightly adjustable and the horizontal angle could be changed depending on a driver's seated eye point, viewing angle, and personal preference.

Photo 19. Transit control head screen position

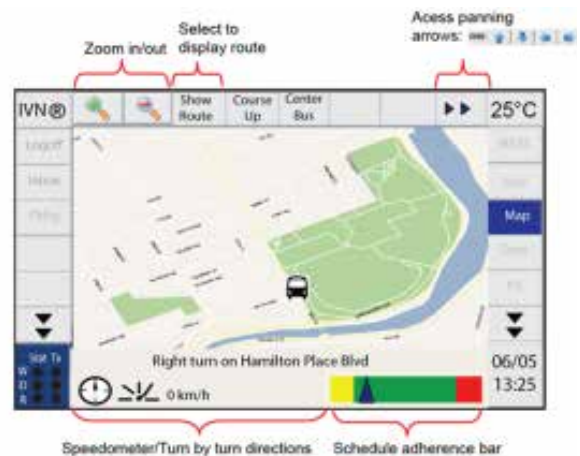
The input functions of the TCH were locked out to the driver when the bus was travelling at speeds in excess of 16 km/h (10 mph). At this speed, a map display was automatically displayed. However, input controls related to the map features, such as zoom, route shown, route options, panning, speedometer, turn-by-turn directions, and the schedule adherence bar, remained active at speeds above 16 km/h (Photo 20).

Photo 20. Transit control head display

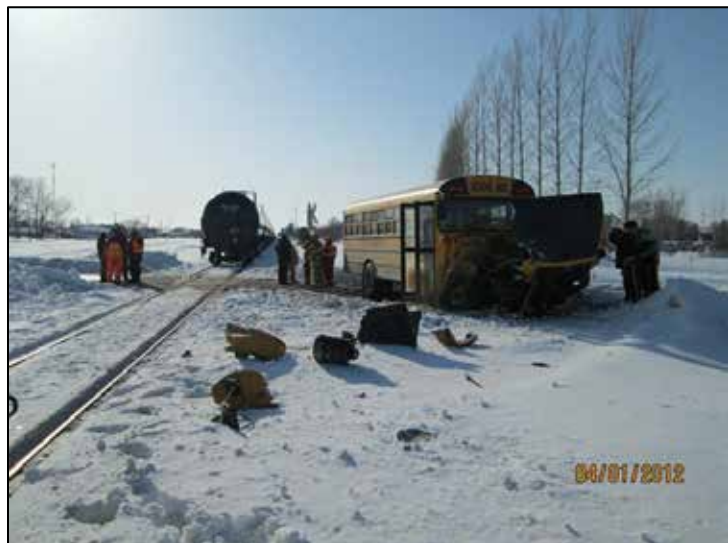
At about 1515 Central Standard Time on 26 March 2013, Canadian National (CN) freight train L50041-26 was proceeding eastward at 25 mph (40.2 km/h) on the Lampman Subdivision in Carlyle, Saskatchewan, when it struck a southbound school bus (the bus) transporting 7 elementary school children at the 4th Street East crossing (Photo J1). One passenger suffered minor injuries. The train weighed approximately 3000 tons and was about 1800 feet long.

Photo J1. Accident scene looking west (Source: Canadian National)

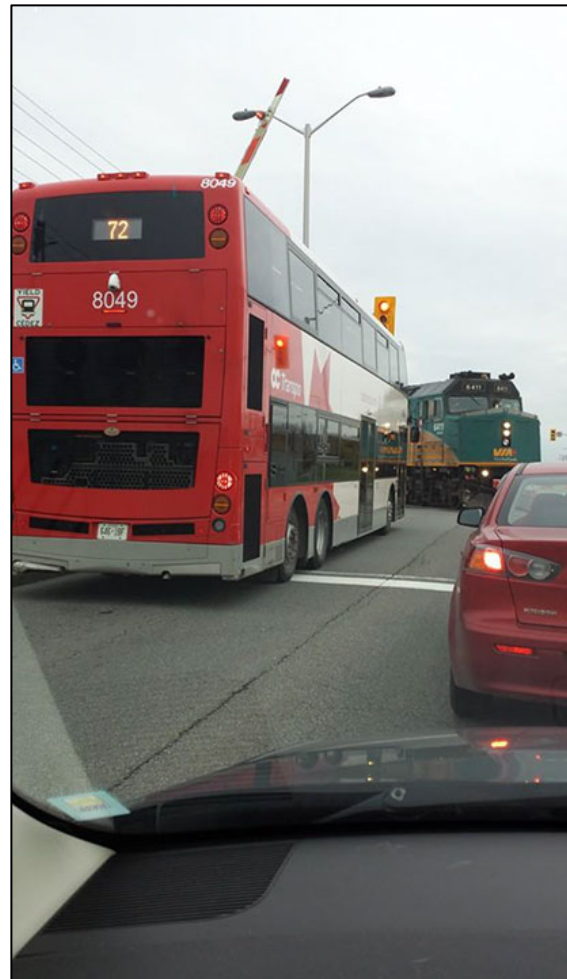
At 0749:02, the traffic signal turned to amber and then to red at 0749:07. During this sequence, OC Transpo bus 8049 came to a stop for the traffic light at a location that was about 25 feet (7.62 m) beyond the crossing roadway stop line. At 0749:33, the crossing AWD protection activated for a westbound VIA passenger train (southward at this location). Shortly thereafter (0749:41), a crossing gate lowered onto the roof of the bus (Photo K1). At 0750:14, the train arrived at the crossing. At 0750:44, the train cleared the crossing after which traffic resumed on Fallowfield Road.
